Section 6: Installation Photographs

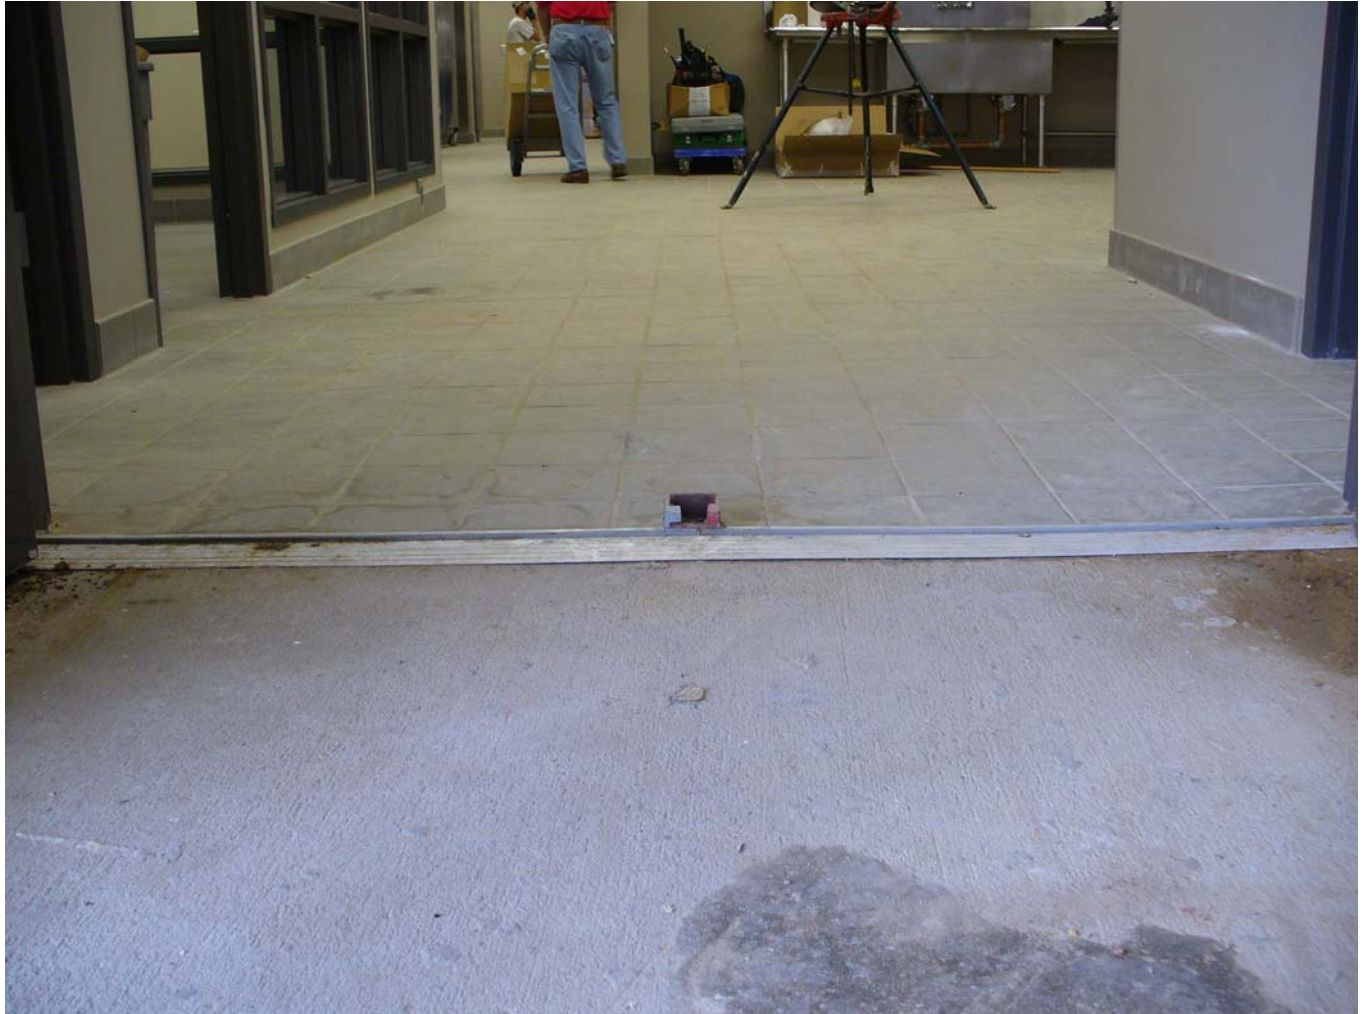
Improper installation of loading dock threshold.

- removable astragal bracket in the path of travel
- weather strip above threshold
