Section 6: Installation Photographs

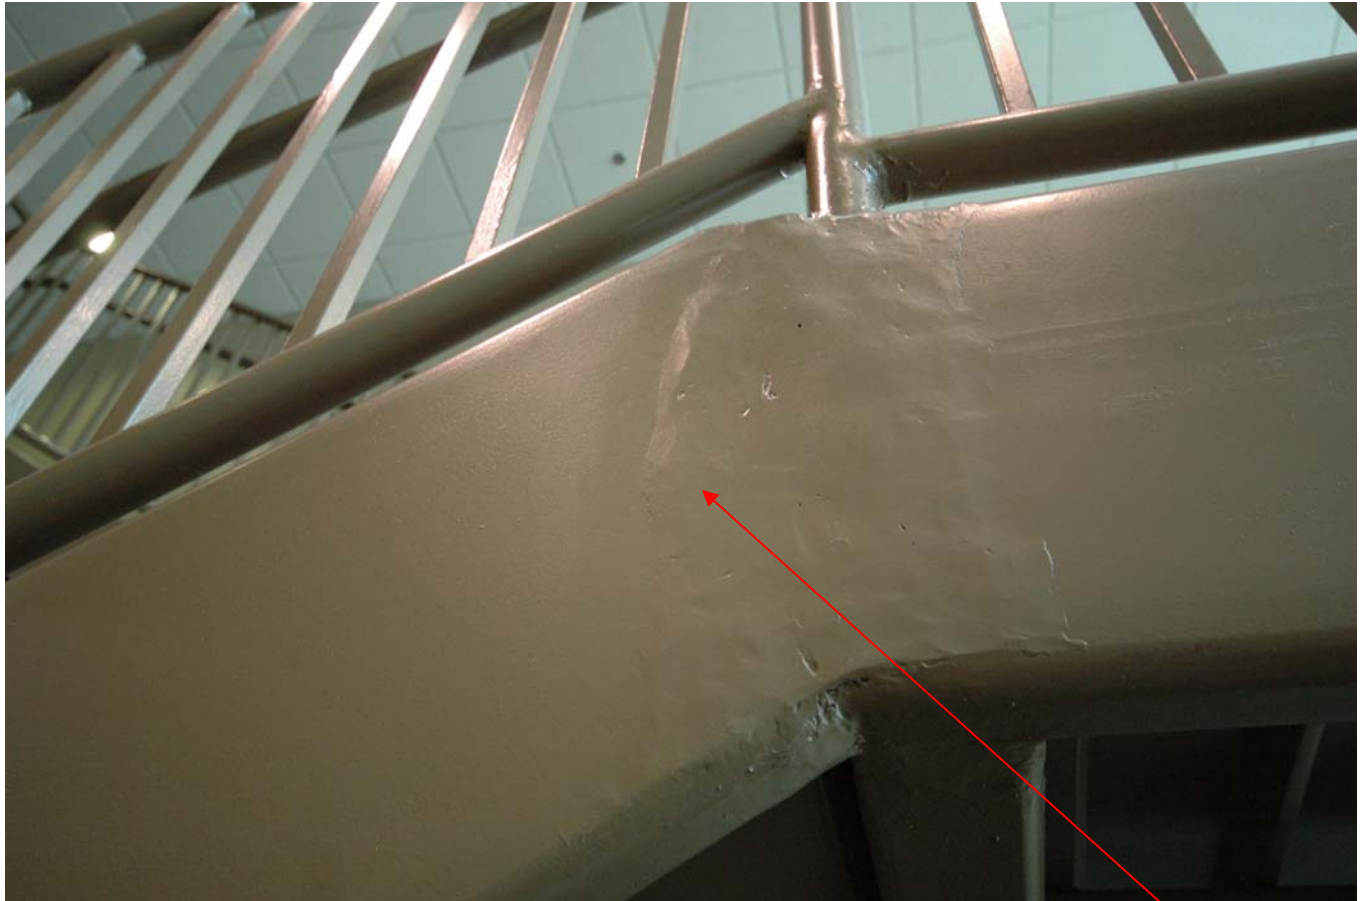
AVOID: Finish of stair stringer/landing joint to be seamless and smooth. All exposed steel to meet AESS standards.

Poor joint finish
