Section 6: Installation Photographs

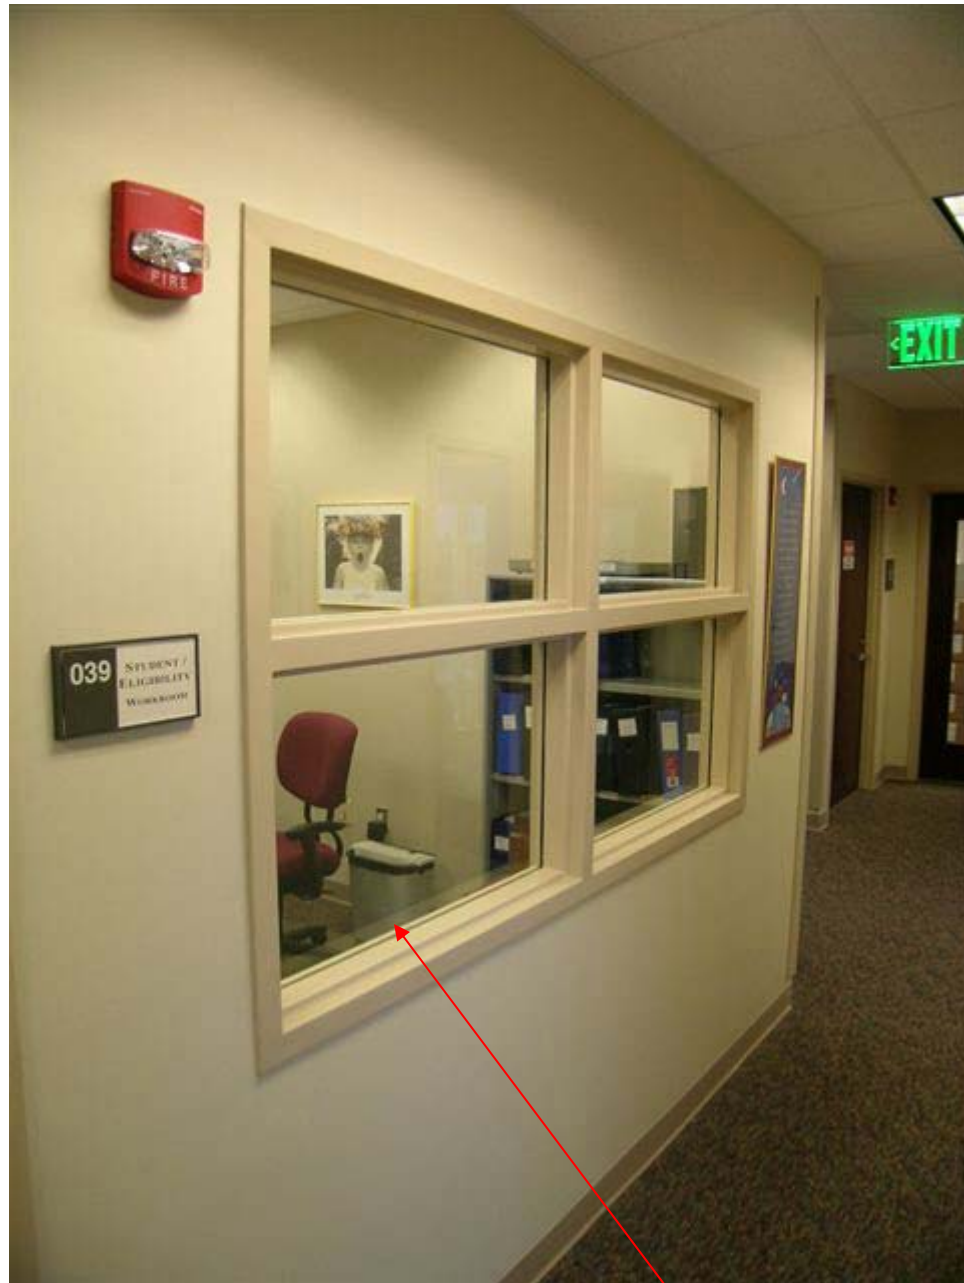
Standard interior view window condition with applied glass stop on “secured” side of frame.

Glass stop on “secured side” of frame.
